**Report on the standing building survey  
6 Balgownie Road, Bridge of Don  
Aberdeen AB23 8JP**

**Alison Cameron**  
**Cameron Archaeology Ltd**  
8 March 2012

# Report on the standing building survey, 6 Balgownie Road, Bridge of Don, Aberdeen AB23 8JP

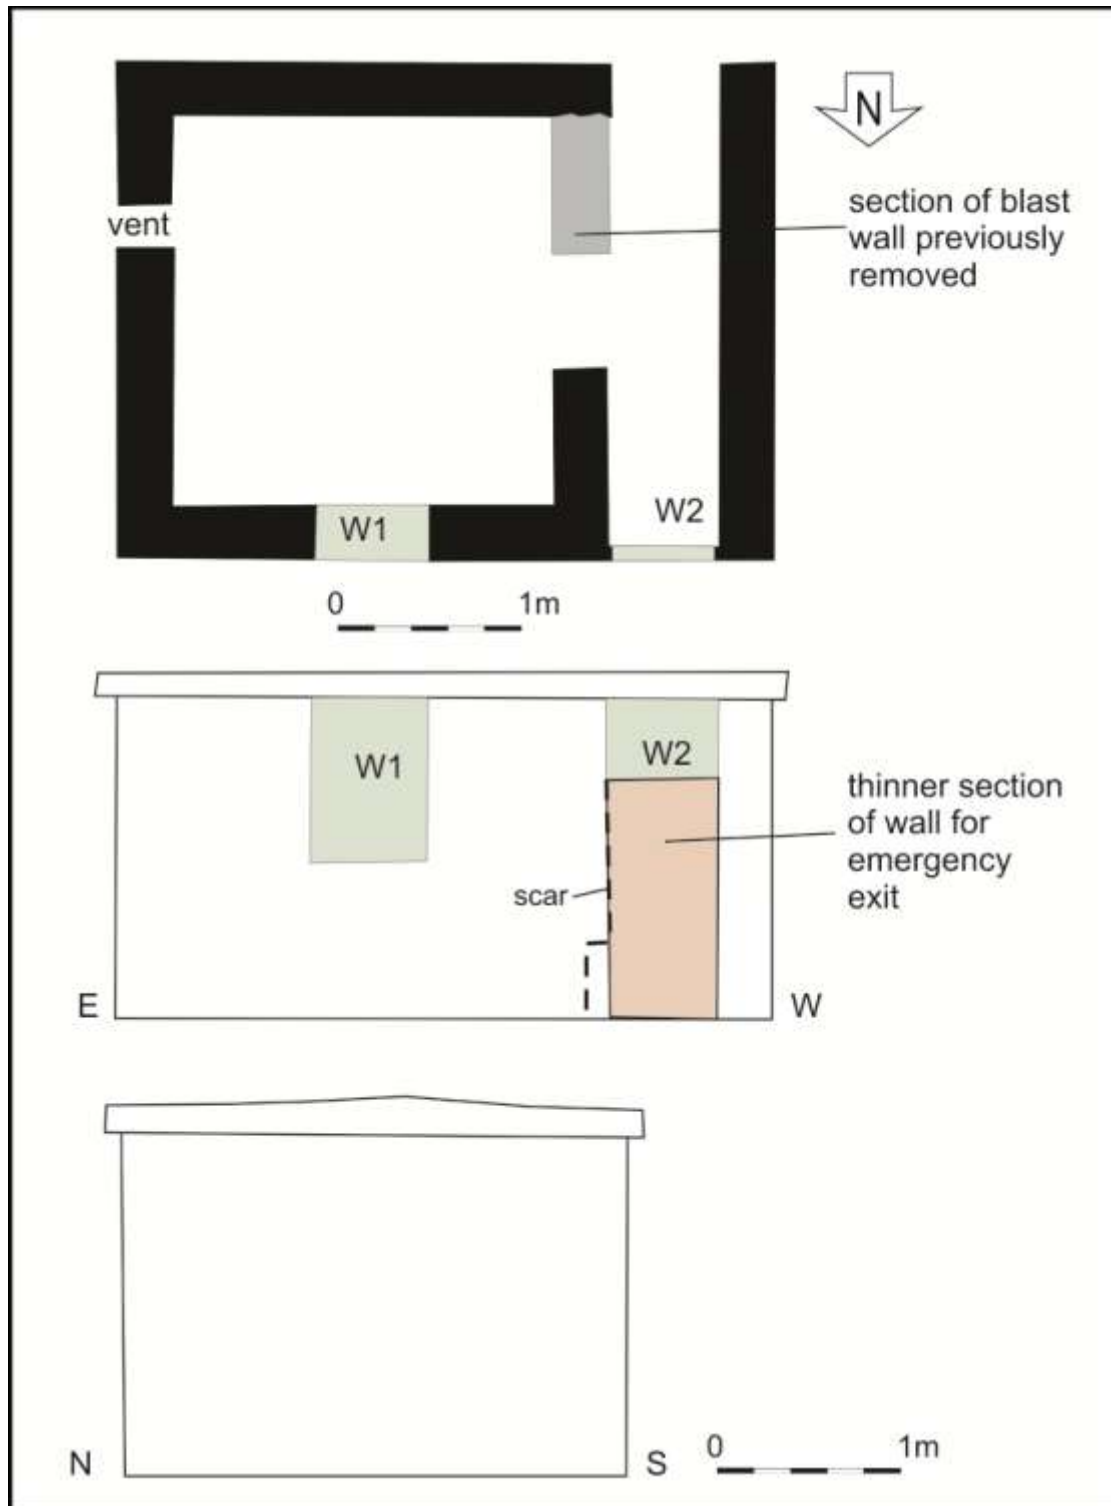
Illus 3 Top Plan of the air raid shelter; middle north elevation; bottom west elevation

The main room is 2.1m x 2.1m in size with a 0.6m wide door leading to the interior corridor; most of the walls are 0.29m thick. Two windows in the north wall are probably not original although fittings for shutters survive internally. The north wall is constructed from concrete blocks (0.52 x 0.17cm) whilst the remainder of the walls and roof are constructed of concrete poured into wooden shuttering (0.15m wide and 1.1m long).

The outer western room is 0.7m wide and formed an inner corridor along the west side of the structure; it was divided from the main shelter room by a 0.29m thick blast wall which had been partially removed after the shelter went out of use. The north wall of this corridor is 0.07m thick and forms a kick-out panel. Where only one entrance was supplied, an emergency exit was provided in the form of a thinner section of wall which allowed people to escape if the main door became blocked. A scar on the north wall (Illus 3) indicates the line between the thinner and thicker sections of wall.

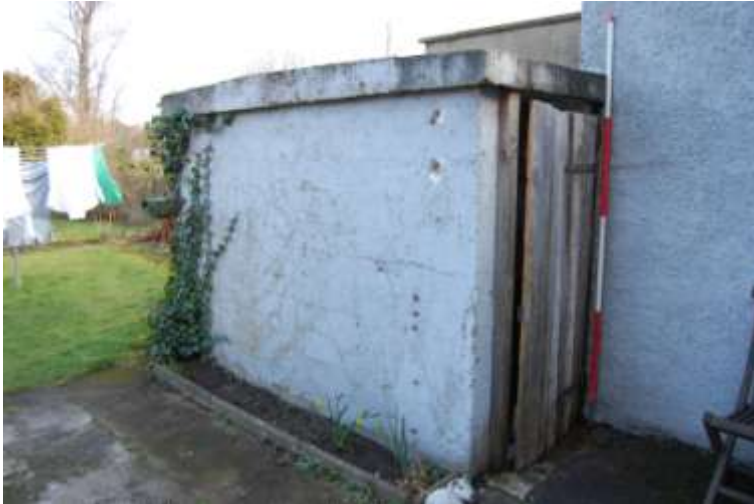
Illus 4 The shelter from the SW showing entrance into corridor

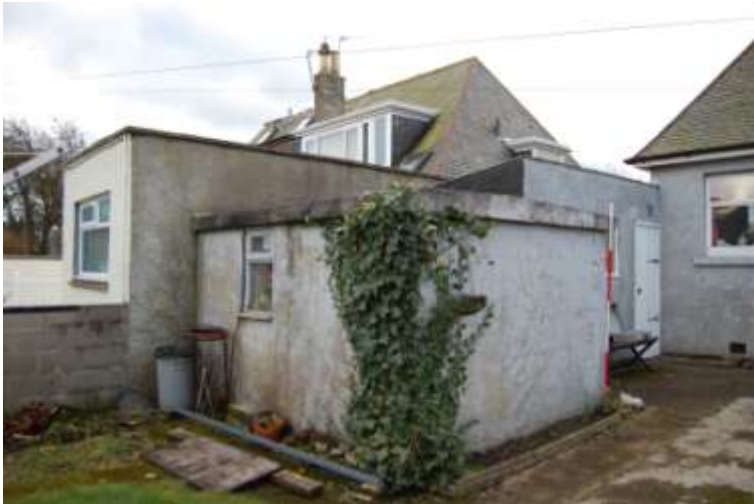
Illus 5 The shelter from the NW

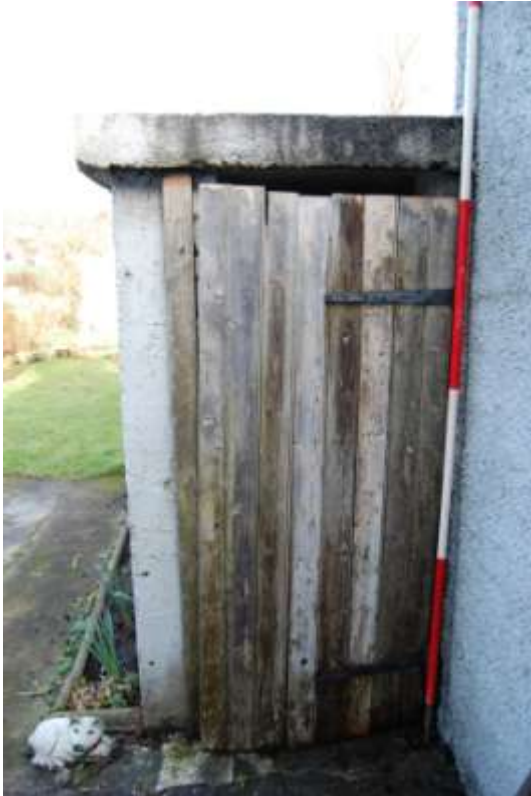
Illus 6 Entrance to the shelter in south wall

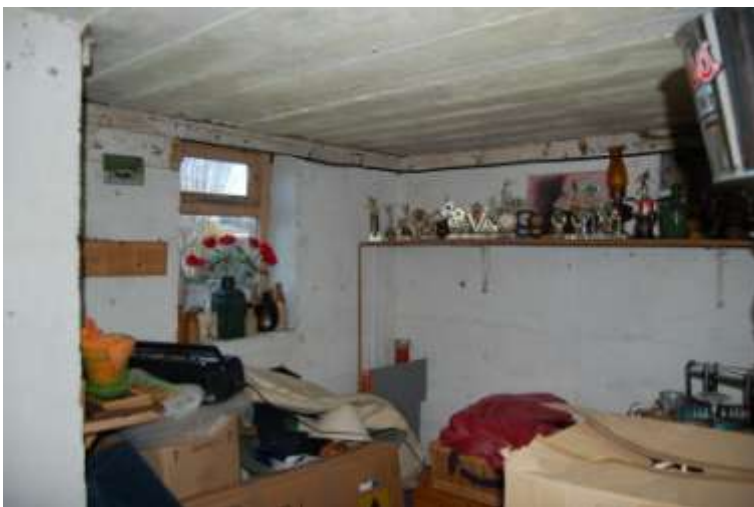
Illus 7 Main shelter facing NE showing Window 1 and shuttering marks on roof

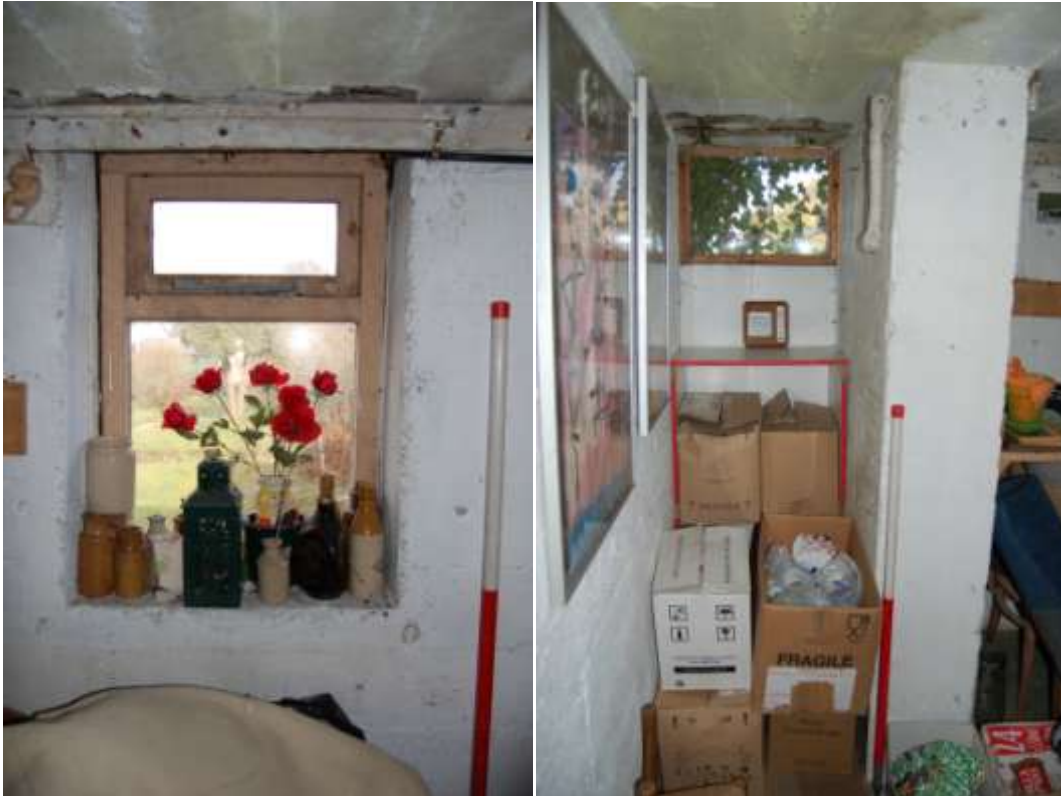
Illus 8 Window 1 (left) Window 2 (right) in north wall

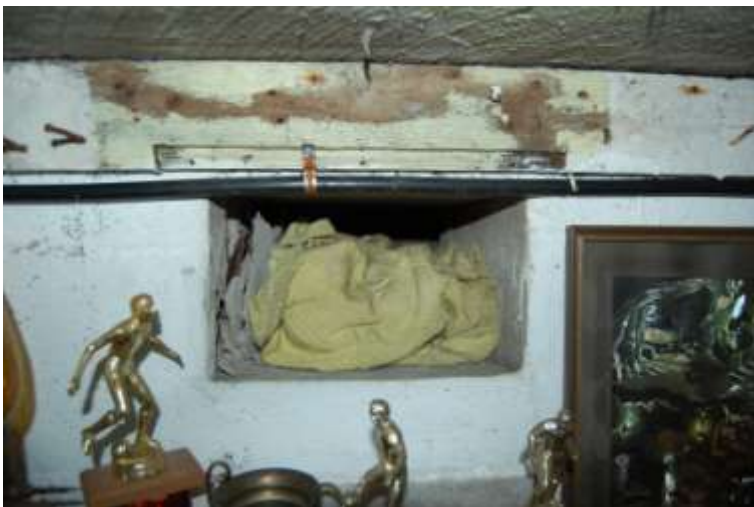
Illus 9 Vent in east wall of shelter

Fittings survive where both the inner and outer door would have been hung. A vent in the east wall (Illus 9) would have been the only source of ventilation when the shelter doors were closed.
